ANALYSIS OF LIQUID ROCKET TANKAGE FOR MODEL
LR58-RM-4 LIQUID PROPELLANT THRUST UNIT FOR THE
BULLPUP MISSILE

Bell Aerospace Company

AFRPL-TR-75-73

FINAL REPORT

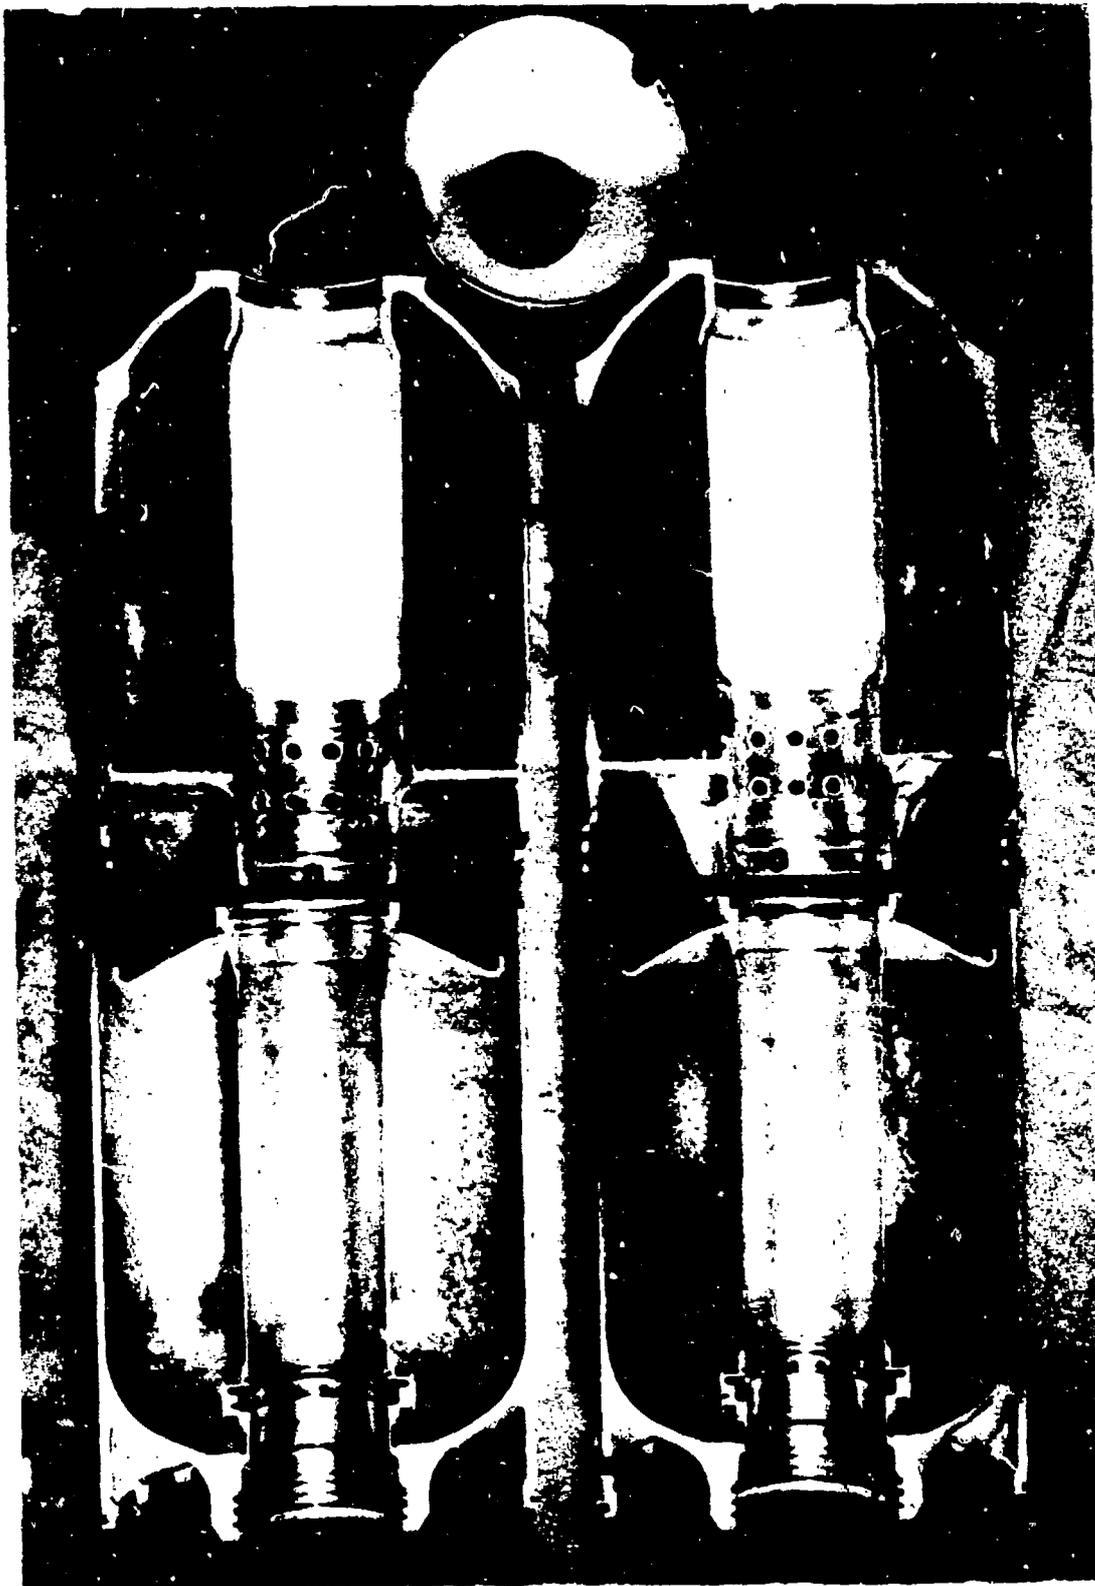
FIGURE 2. SECTIONED VIEW OF THRUST UNIT SHOWING INTERIOR
CONDITION AFTER 10-YEAR STORAGE WITH PROPELLANTS.

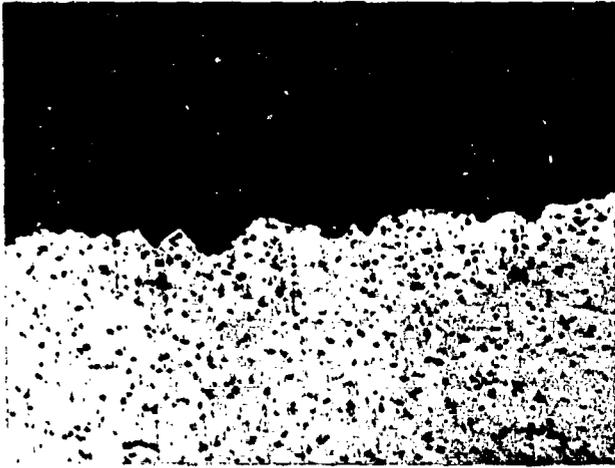
A section was taken through the corroded area of an oxidizer exposed shear disc, and a metallographic sample prepared. The photomicrograph of this area is shown in Figure 8. Metal attack initiates as extremely small shallow pits which join together, resulting in the area type corrosion observed.

FIGURE 8. CROSS SECTION THROUGH SHEAR DISC SHOWN IN FIGURE 7. SHOWING GENERAL CORROSION OCCURRING ON OXIDIZED EXPOSED SURFACE OF ALUMINUM ALLOY.
